SOUTH SAN FRANCISCO

self evaluation and transition plan

Appendix F: Intersections Survey

The ADA facility reports represent a survey of existing conditions of South San Francisco's intersections with signalized pedestrian control devices. Assessment of the facilities includes detailed measurements comparing the existing conditions of the facility to the codes and standard contained in the following:

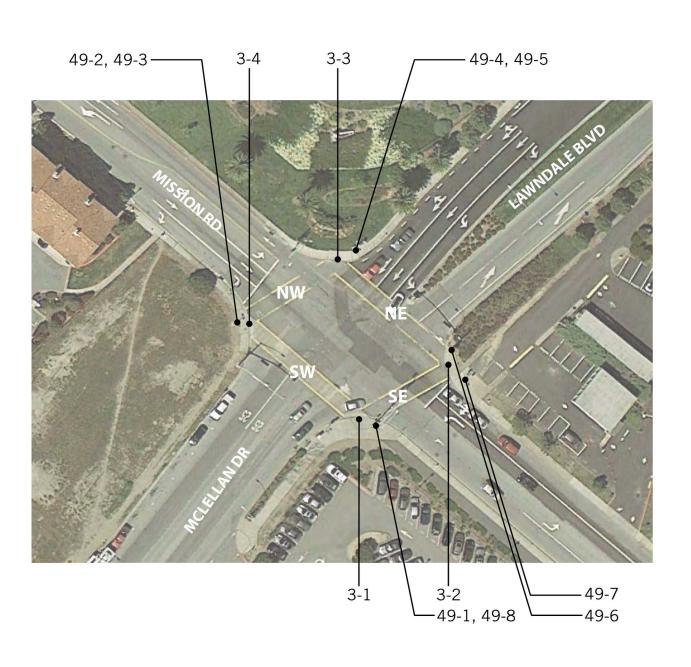
001: Mission & McLellan

Northe	ast Crosswalk	
3 - 2	Curb Ramp Priority:	
Install, r	eplace or modify curb ramp	\$2,500
Notes:	Slope of curb ramp is 8.7% (8.33% max). Cross slope of curb ramp is 4.0% max).	(2.0%
State:	1127B.5.3	
Federal:	405.2, 405.3, 406.1	
Provide	detectable warning strip	\$1,000
Notes:	A detectable warning (truncated domes) is not provided.	
State:	1127B.5.7, IR11B-4	
Federal:	-	
Provide	level landing	\$250
Notes:	Slope of the top landing is 3.5% (2.0% max).	
State:	1127B.5.4	
Federal:	-	
Provide	surface texturing	\$1,000
Notes:	Surface finish does not contrast with surrounding sidewalks.	
State:	1127B.5.5	
Federal:	-	
Repair s	urface	\$250
Notes:	The transition from the gutter to the curb ramp is not flush and free of level changes. There is a 3/8" lip at the base of the ramp.	
State:	1127B.5.3	
Federal:	303.2, 303.3, 405.4

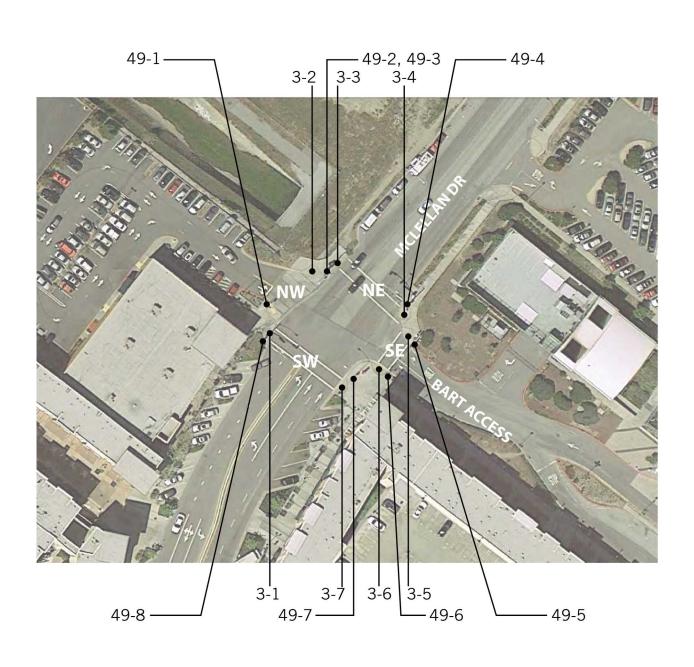
Northe	ast Crosswalk	
3 - 3	Curb Ramp P	riority:
Install, ı	eplace or modify curb ramp	\$2,500
Notes:	Slope of curb ramp is 8.8% (8.33% max).	
State:	1127B.5.3	
Federal:	405.2, 405.3, 406.1	
Provide	level landing	\$250
Notes:	Slope of the top landing is 3.6% (2.0% max).	
State:	1127B.5.4	
Federal:	-	
Provide	surface texturing	\$1,000
Notes:	Grooved border is 11.5" wide (12" min width with grooves 3	3/4" on center).
State:	1127B.5.6	
Federal:	-	
3 - 4	Curb Ramp	riority:
Provide	level landing	\$250
Notes:	Slope of the top landing is 4.0% (2.0% max).	
State:	1127B.5.4	
Federal:	-

Northeast Crosswalk 49 - 3 Pedestrian Control Device Priority: Provide both vibrotactile and audible indicators \$1,000 Notes: The pedestrian signal does not provide both audible and vibrotactile walk indications (accessible pedestrian signals shall have both audible and vibrotactile walk indications). CAMUTCD 4E.11 State: Federal: MUTCD 4E.11 Provide color coding indicator above pedestrian pushbutton \$150 A color coding indicator is not located above the pedestrian pushbutton (textured Notes: horizontal yellow band 2" wide encircling the pole and a 1" wide dark border band above and below this yellow band). CBC 1117B.5.9 State: Federal: -\$750 Raise or lower pushbutton height The pushbutton is located at a height of 39" above the ground (42" min to 48" max). Notes: State: CAMUTCD 4E.08 Federal: MUTCD 4E.08 \$75,000 Relocate pedestrian pushbutton Notes: The two pedestrian signal devices on the same corner are on the same pole (10' min apart). State: CAMUTCD 4E.08 Federal: MUTCD 4E.08

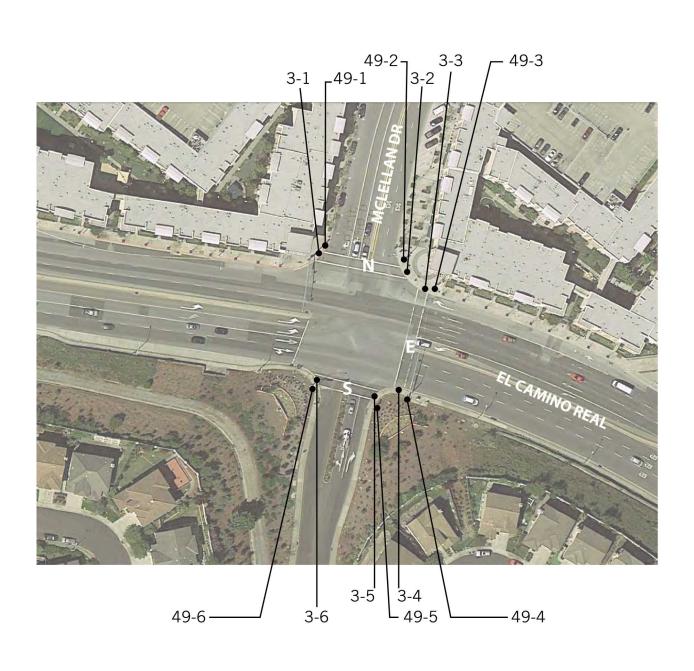
003: McLellan & ElCamino

East C	osswalk	
3 - 3	Curb Ramp	Priority:
Provide	level landing	\$250
Notes:	Slope of the grooved border in the top la	anding is 4.4% (2.0% max).
State:	1127B.5.4	
Federal:	-	
3 - 4	Curb Ramp	Priority:
Install, r	eplace or modify curb ramp	\$2,500
Notes:		is 11.2% (8.33% max). Bottom landing of 0% (2.0% max). Width of ramp, not including
State:	1127B.5.2, 1127B.5.3, 1127B.5.4	
Federal:	405.2, 405.3, 406.1, 406.3	
Provide	detectable warning strip	\$1,000
Notes:	A detectable warning (truncated domes	is not provided.
State:	1127B.5.7, IR11B-4	
Federal:	-	
Provide	level landing	\$250
Notes:	Slopes of the top landings of the paralle Counter slope at the base of the curb ra	I curb ramp are 3.3% and 3.2% (2.0% max). mp is 11.9% (5.0% max).
State:	1127B.5.3, 1127B.5.4	
Federal:	406.2	
Provide	surface texturing	\$1,000
Notes:	Surface finish does not contrast with su	rounding sidewalks.
State:	1127B.5.5	
Federal:	-

North (rosswalk	
3 - 1	Curb Ramp	Priority:
Provide	level landing	\$250
Notes:	Counter slope at the base of the curb ra	amp is 5.3% (5.0% max).
State:	1127B.5.3	
Federal:	406.2	
Provide	surface texturing	\$1,000
Notes:	Grooved border is 11-1/2" wide (12" mi	n width with grooves 3/4" on center).
State:	1127B.5.6	
Federal:	-	
Repair s	urface	\$250
Notes:	Surface of the ramp is not free of level in the concrete.	changes. The curb ramp surface has a crack
State:	1127B.5.3	
Federal:	303.2, 303.3, 405.4	
3 - 2	Curb Ramp	Priority:
Install, r	eplace or modify curb ramp	\$2,500
Notes:	Slope of curb ramp is 8.5% (8.33% max	x).
State:	1127B.5.3	
Federal:	405.2, 405.3, 406.1	
Provide	level landing	\$250
Notes:	Slope of the top landing in the grooved	border is 5.9% (2.0% max).
State:	1127B.5.4	
Federal:	-	
Provide	surface texturing	\$1,000
Notes:	There is a manhole cover in the top of t	the grooved border.
State:	1127B.5.6	
Federal:	-

- X - 6	Curb Ramp Priority:	
3 - 6		ФО БОО
Notes:	replace or modify curb ramp Width of ramp, not including flared sides, is 46" (48" min). The slope of one curb ramp side is 10.7% (8.33% max). Bottom landing of the parallel curb range of 4.2% (2.0% max).	
State:	1127B.5.2, 1127B.5.3, 1127B.5.4	
Federal:	405.2, 405.3, 406.1, 406.3	
Provide	detectable warning strip	\$1,000
Notes:	A detectable warning (truncated domes) is not provided.	
State:	1127B.5.7, IR11B-4	
Federal:		
Provide	level landing	\$250
Notes:	Running slope of one top landings is 7.3% (2.0% max). Cross slope of the stop landing is 3.4% (2.0% max). Counter slope at the base of the curb ramp

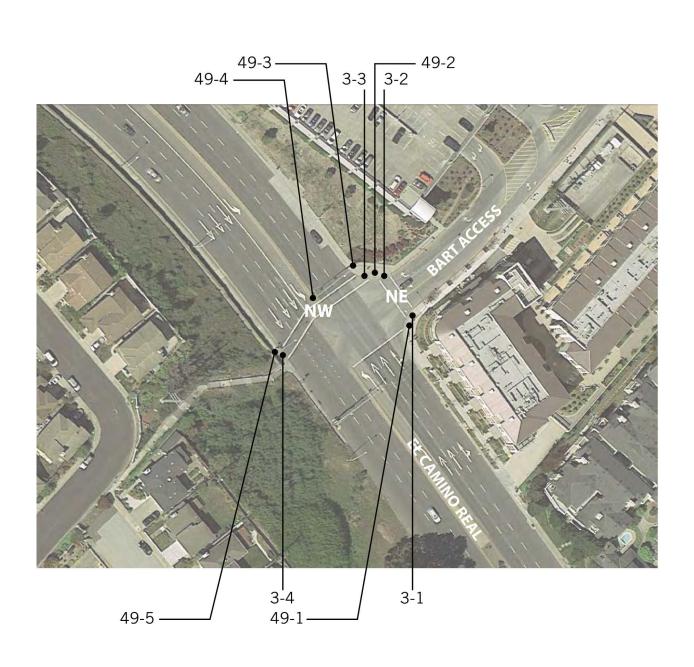
ast Crosswalk	
3 - 1	Curb Ramp	Priority:
Provide	level landing	\$250
Notes:	Counter slope at the base of the curb landing is 3.5% (2.0% max).	o ramp is 8.8% (5.0% max). Slope of the top
State:	1127B.5.3, 1127B.5.4	
Federal:	406.2	
3 - 2	Curb Ramp	Priority:
Install, r	eplace or modify curb ramp	\$2,500
Notes:	Width of ramp, not including flared si is 3.5% (2.0% max).	des, is 47" (48" min). Cross slope of curb ramp
State:	1127B.5.2, 1127B.5.3	
Federal:	405.2, 405.3, 406.1	
Provide	detectable warning strip	\$1,000
Notes:	A detectable warning (truncated dom	nes) is not provided.
State:	1127B.5.7, IR11B-4	
Federal:	-	
Provide	level landing	\$250
Notes:		" by 48" min). Slope of the top landing is 5.3% se of the curb ramp is 10.4% (5.0% max).
State:	1127B.5.3, 1127B.5.4	
Federal:	406.2	
Provide	surface texturing	\$1,000
Notes:	Surface finish does not contrast with	surrounding sidewalks.
State:	1127B.5.5	
Federal:	-

ast Crosswalk	
49 - 1	Pushbutton Crossing BART Access	Priority:
Provide	both vibrotactile and audible indicators	\$1,000
Notes:	The pedestrian signal does not provide both audible indications (accessible pedestrian signals shall have walk indications).	
State: Federal:	CAMUTCD 4E.11 MUTCD 4E.11	
Provide	color coding indicator above pedestrian pushbutt	on \$150
Notes:	A color coding indicator is not located above the pede horizontal yellow band 2" wide encircling the pole and above and below this yellow band).	
State:	CBC 1117B.5.9	
Federal:	-	
Raise or	lower pushbutton height	\$750
Notes:	The pushbutton is located at a height of 39" above the	e ground (42" min to 48" max).
State:	CAMUTCD 4E.08	
Federal:	MUTCD 4E.08	
49 - 2	Pushbutton Crossing BART Access	Priority:
Raise or	lower pushbutton height	\$750
Notes:	The pushbutton is located at a height of 38" above the	e ground (42" min to 48" max).
State:	CAMUTCD 4E.08

est Crosswalk	· · ·	
49 - 4	Pushbutton Crossing El Camino Real	Priority:	
Provide	both vibrotactile and audible indicators		\$1,000
Notes:	The pedestrian signal does not provide both audit indications (accessible pedestrian signals shall have walk indications).		rotactile
State:	CAMUTCD 4E.11		
Federal:	MUTCD 4E.11		
Provide	color coding indicator above pedestrian pushb	utton	\$150
Notes:	A color coding indicator is not located above the phorizontal yellow band 2" wide encircling the pole above and below this yellow band).		
State:	CBC 1117B.5.9		
Federal:	-		
Replace	pushbutton		\$1,000
Notes:	The operating force of the push button requires 10	0 lbs of force (5 lbs max).
State:	-		
Federal:	309.4		
49 - 5	Pushbutton Crossing El Camino Real	Priority:	
Provide	both vibrotactile and audible indicators		\$1,000
Notes:	The pedestrian signal does not provide both audit indications (accessible pedestrian signals shall hawalk indications).		rotactile

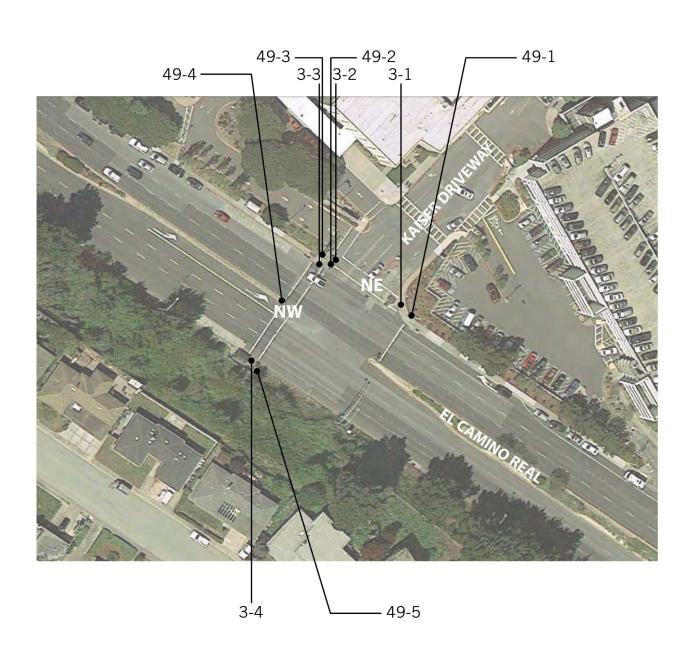
3 - 1	Curb Ramp	Priority:
Install, r	eplace or modify curb ramp	\$2,500
Notes:	The slope of flared sides are 26.1% and 48" deep). Slope of curb ramp is 11.2%	nd 26.9% (8.33% max with a landing less than % (8.33% max).
State:	1127B.5.3, 1127B.5.4	
Federal:	405.2, 405.3, 406.1, 406.3	
Provide	detectable warning strip	\$1,000
Notes:	A detectable warning (truncated domes	s) is not provided.
State:	1127B.5.7, IR11B-4	
Federal:	-	
Provide	level landing	\$250
Notes:	No landing provided.	
State:	1127B.5.4	
Federal:	-	
Provide	surface texturing	\$1,000
Notes:	A one foot wide grooved border extend is not provided. Surface finish does no	ding the full width and depth of the curb ramp t contrast with surrounding sidewalks.
State:	1127B.5.5, 1127B.5.6	
Federal:	-	
Repair s	urface	\$250
Notes:	The transition from the gutter to the cu changes. There is a 1-1/2" level chang street surface.	rb ramp is not flush and free of level be between the base of the curb ramp and the

State:	1127B.5.3	
Federal:	303.2, 303.3, 405.4

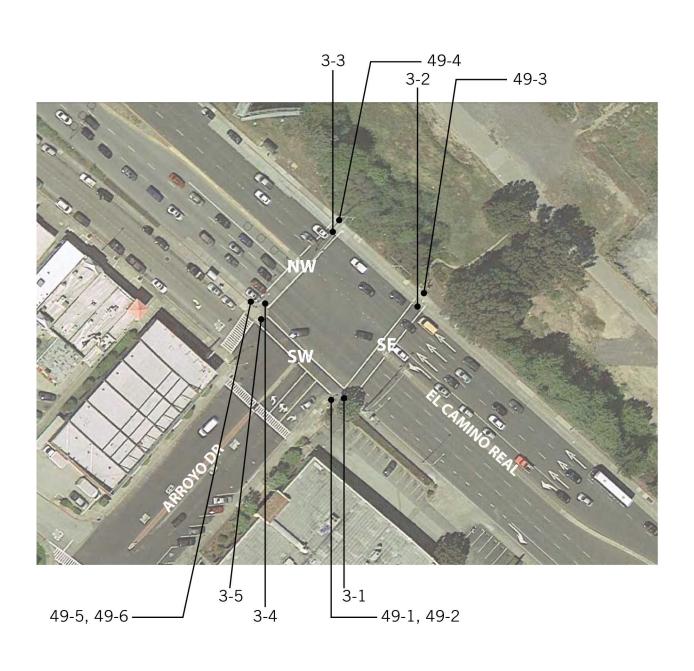
Northw	est Crosswalk	
3 - 3	Curb Ramp	Priority:
Install, r	eplace or modify curb ramp	\$2,500
Notes:	The slope of one parallel curb ramp is 18.4% (8.33% m parallel curb ramp has a slope of 3.1% (2.0% max).	nax). Bottom landing of the
State:	1127B.5.3, 1127B.5.4	
Federal:	405.2, 405.3, 406.1, 406.3	
Provide	detectable warning strip	\$1,000
Notes:	A detectable warning (truncated domes) is not provided	d.
State:	1127B.5.7, IR11B-4	
Federal:	-	
Provide	level landing	\$250
Notes:	Slope of the parallel landings are 2.8% and 3.8%, with border (2.0% max).	a 5.4% slope on the grooved
State:	1127B.5.4	
Federal:	-	
Provide	surface texturing	\$1,000
Notes:	Surface finish does not contrast with surrounding sidew	valks.
State:	1127B.5.5	
Federal:	-	
Repair s	urface	\$250
Notes:	The transition from the gutter to the curb ramp is not fluchanges. There is a 1/2" deep level change around the base of the curb ramp.	
State:	1127B.5.3

Federal:	303.2, 303.3, 405.4

State:	-	
Federal:	305.2	
Replace	pushbutton	\$1,000
Notes:	The operating force of the push button requires 8 lbs of force	ce (5 lbs max).
State:	-	
Federal:	309.4

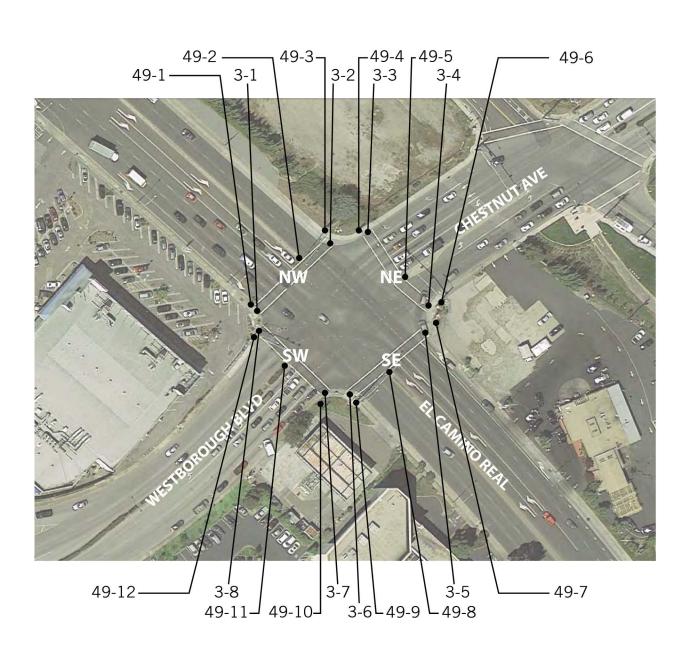
Northe	ast Crosswalk	
3 - 3	Curb Ramp	Priority:
Install, r	eplace or modify curb ramp	\$2,500
Notes:		s 10.2% with a cross slope of 8.7% (8.33% urb ramp has a slope of 5.5% (2.0% max).
State:	1127B.5.3, 1127B.5.4	
Federal:	405.2, 405.3, 406.1, 406.3	
Provide	detectable warning strip	\$1,000
Notes:	A detectable warning (truncated dome	es) is not provided.
State:	1127B.5.7, IR11B-4	
Federal:	-	
Provide	level landing	\$250
Notes:		gs are 3.6% and 5.8%, with a slope of 8.5% is atter slope at the base of the curb ramp is
State:	1127B.5.3, 1127B.5.4	
Federal:	406.2	
Provide	surface texturing	\$1,000
Notes:	Surface finish does not contrast with s	surrounding sidewalks.
State:	1127B.5.5	
Federal:	-	
Repair s	urface	\$250
Notes:	Surface of the ramp is not free of leve damaged concrete near the grooved I	el changes. There is a 1/2" level change due to border.
State:	1127B.5.3	
Federal:	303.2, 303.3, 405.4

Northe	ast Crosswalk	
3 - 4	Curb Ramp Priority:	
Install, r	eplace or modify curb ramp	\$2,500
Notes:	The cross slope of the parallel curb ramps are 2.5% and 3.2% (2.0% max) ramp, not including flared sides, is 47" (48" min).	. Width of
State:	1127B.5.2, 1127B.5.3, 1127B.5.4	
Federal:	406.3	
Provide	detectable warning strip	\$1,000
Notes:	A detectable warning (truncated domes) is not provided.	
State:	1127B.5.7, IR11B-4	
Federal:	-	
Provide	level landing	\$250
Notes:	Counter slope at the base of the curb ramp is 5.8% (5.0% max). Slope of t parallel curb ramp landing is 3.0% (2.0% max).	he
State:	1127B.5.3, 1127B.5.4	
Federal:	406.2	
Provide	surface texturing	\$1,000
Notes:	Surface finish does not contrast with surrounding sidewalks.	
State:	1127B.5.5	
Federal:	-

State:	-	
Federal:	309.4	
49 - 5	Pushbutton Crossing Chestnut	Priority:
Replace	pushbutton	\$1,000
Notes:	The operating force of the push button requires 11 lbs	of force (5 lbs max).
State:	-

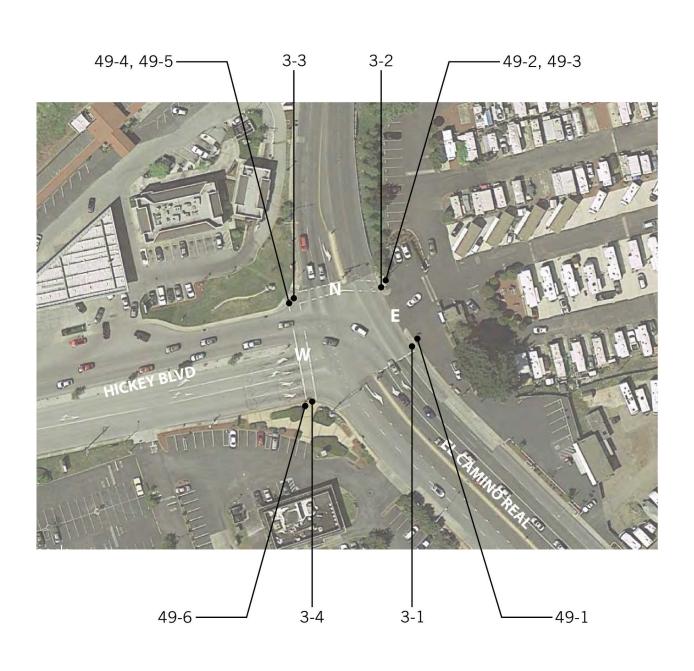
East C	rosswalk	
3 - 1	Curb Ramp	Priority:
Install, r	eplace or modify curb ramp	\$2,500
Notes:	The slope of the flared sides are 18.3% and 22.2% (1 is 11.9% (8.33% max).	0% max). Slope of curb ramp
State:	1127B.5.1, 1127B.5.3, 1127B.5.4	
Federal:	405.2, 405.3, 406.1, 406.3, 406.6	
Provide	detectable warning strip	\$1,000
Notes:	A detectable warning (truncated domes) is not provide	ed.
State:	1127B.5.7, IR11B-4	
Federal:	-	
Provide	level landing	\$250
Notes:	Counter slope at the base of the curb ramp is 5.5% (5 of the curb ramp with 1-3/4" openings (1/2" max).	5.0% max). Grate at the base
State:	1127B.5.3	
Federal:	406.2	
Provide	surface texturing	\$1,000
Notes:	es: A one foot wide grooved border that extends the full width and depth of the curb ramp, with grooves approximately 3/4" on center, is not provided on the sidewalk surface. Surface finish does not contrast with surrounding sidewalks.	
State:	1127B.5.5, 1127B.5.6

Federal:	-

3 - 4	Curb Ramp Pr	riority:	
nstall, r	eplace or modify curb ramp		\$2,500
Notes:	The slope of flared sides are 10.5% and 11.5% (10% max). 10.5% (8.33% max).	. Slope of curb	ramp is
State: Federal:	1127B.5.3, 1127B.5.4 405.2, 405.3, 406.1, 406.3		
Provide	detectable warning strip		\$1,000
Notes:	A detectable warning (truncated domes) is not provided.		
State: Federal:	1127B.5.7, IR11B-4		
Provide	surface texturing		\$1,000
Notes:	A utility box cover is located in the one foot wide grooved be width and depth of the curb ramp.	order the exten	ids the ful
State: Federal:	1127B.5.6 -		
Repair s	urfooo		Φ ΩΕΩ
itepaii s	uriace		\$250
Notes:	The transition from the gutter to the curb ramp is not flush a due to brick trim.	and free of leve	
Notes:	The transition from the gutter to the curb ramp is not flush a	and free of leve	
Notes: State:	The transition from the gutter to the curb ramp is not flush a due to brick trim.	and free of leve

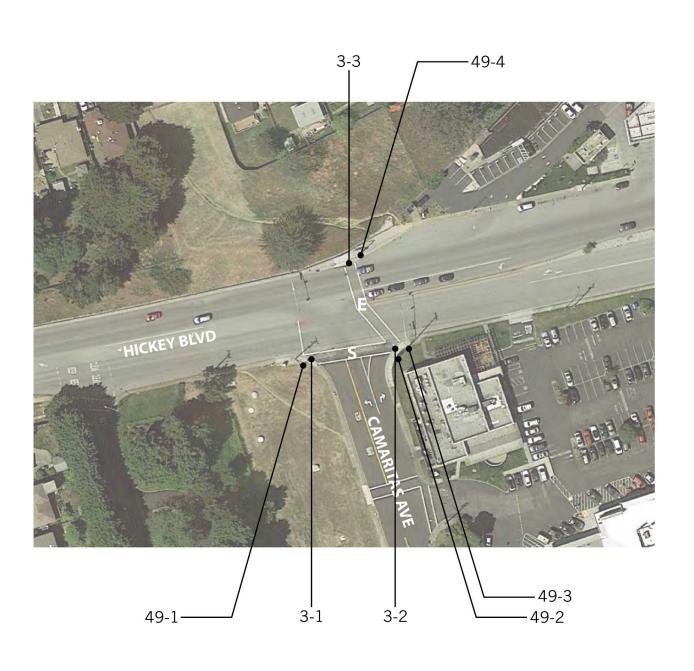
020: Camaritas & Hickey

East Crosswalk		
3 - 3	Curb Ramp	Priority:
Install, r	eplace or modify curb ramp	\$2,500
Notes:	Cross slope of curb ramp is 2.9% (2.0% max).	
State:	1127B.5.3	
Federal:	405.2, 405.3, 406.1

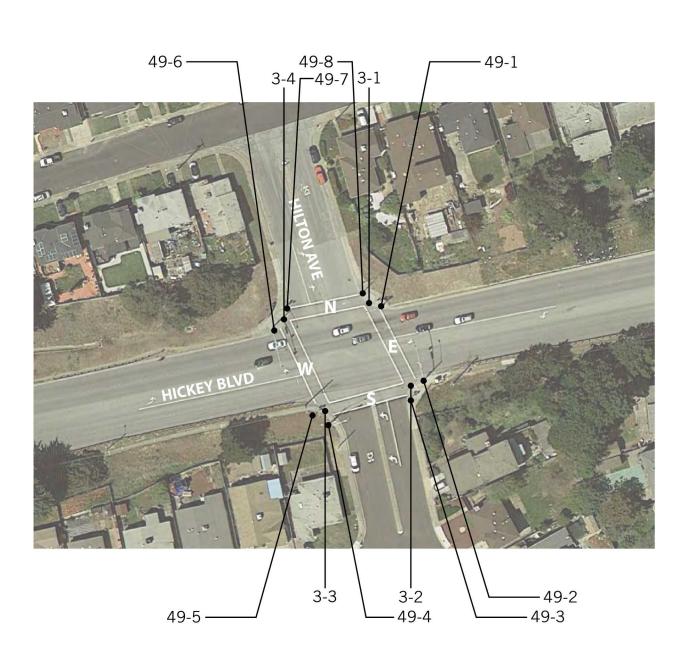
East C	rosswalk	
3 - 1	Curb Ramp	Priority:
Install, r	eplace or modify curb ramp	\$2,500
Notes:	The slope of one flared side is 23.7% (10% max (8.33% max). Cross slope of curb ramp is 12.4%	, .
State:	1127B.5.3, 1127B.5.4	
Federal:	405.2, 405.3, 406.1, 406.3	
Provide	detectable warning strip	\$1,000
Notes:	A detectable warning (truncated domes) is not p	provided.
State:	1127B.5.7, IR11B-4	
Federal:	-	
Provide	level landing	\$250
Notes:	Counter slope at the base of the curb ramp is 1 landing is 12.3% (2.0% max).	5.2% (5.0% max). Slope of the top
State:	1127B.5.3, 1127B.5.4	
Federal:	406.2	
Provide	surface texturing	\$1,000
Notes:	Surface finish does not contrast with surrounding	g sidewalks.
State:	1127B.5.5	
Federal:	-

East C	rosswalk	
3 - 2	Curb Ramp	Priority:
Install, r	eplace or modify curb ramp	\$2,500
Notes:	The slope of one flared side is 14.3% (10% max). Cr (2.0% max).	oss slope of curb ramp is 4.0%
State:	1127B.5.3, 1127B.5.4	
Federal:	405.2, 405.3, 406.1, 406.3	
Provide	detectable warning strip	\$1,000
Notes:	A detectable warning (truncated domes) is not provide	led.
State:	1127B.5.7, IR11B-4	
Federal:	-	
Provide	level landing	\$250
Notes:	Counter slope at the base of the curb ramp is 13.0% landing is 4.4% (2.0% max). There is a 1/2" change of and ramp (1/4" max, up to 1/2" with a bevel.	
State:	1127B.5.3, 1127B.5.4	
Federal:	406.2	
Provide	surface texturing	\$1,000
Notes:	Surface finish does not contrast with surrounding sid	ewalks.
State: Federal:	1127B.5.5 -

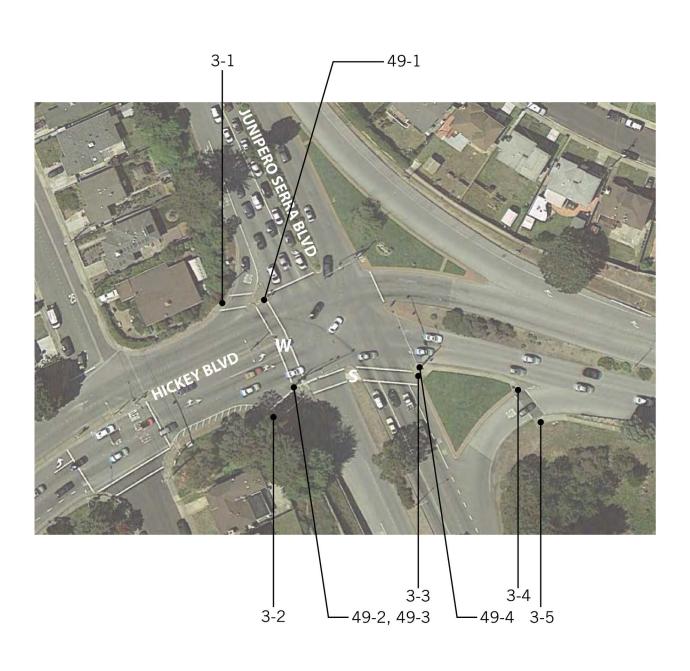
3 - 2	Curb Ramp Priority:	
Install, r	eplace or modify curb ramp	\$2,500
Notes:	The slope of one flared side is 21.6% (8.33% max with a landing less than deep). Slope of curb ramp is 9.8% (8.33% max). Cross slope of curb ramp (2.0% max). Width of ramp, not including flared sides, is 32" wide at the guinches (48" min).	is 7.4%
State:	1127B.5.2, 1127B.5.3, 1127B.5.4	
Federal:	405.2, 405.3, 406.1, 406.3	
Provide	detectable warning strip	\$1,000
Notes:	A detectable warning (truncated domes) is not provided.	
State:	1127B.5.7, IR11B-4	
Federal:	-	
Provide	level landing	\$250
Notes:	A 48" by 48" landing is not provided at the top of the ramp.	
State:	1127B.5.4	
Federal:	-	
Provide	surface texturing	\$1,000
Notes:	Surface finish does not contrast with surrounding sidewalks.	
State:	1127B.5.5	
Federal:	-	
Repair s	urface	\$250
Notes:	The transition from the gutter to the curb ramp is not flush and free of level changes. There is a 3/8" lip at the base of the ramp.

State:	1127B.5.3	
Federal:	303.2, 303.3, 405.4

South (Crosswalk	
3 - 3	Curb Ramp Priority:	
Install, r	eplace or modify curb ramp	\$2,500
Notes:	The slope of one flared side is 23.5% (10% max). Cross slope of curb ramp (2.0% max).	is 3.4%
State:	1127B.5.3, 1127B.5.4	
Federal:	405.2, 405.3, 406.1, 406.3	
Provide	detectable warning strip	\$1,000
Notes:	A detectable warning (truncated domes) is not provided.	
State:	1127B.5.7, IR11B-4	
Federal:	-	
Provide	level landing	\$250
Notes:	Slope of the top landing is 4.2% (2.0% max).	
State:	1127B.5.4	
Federal:	-	
Repair s	urface	\$250
Notes:	The transition from the gutter to the curb ramp is not flush and free of level changes. There is a $1/2$ " lip at the base of the ramp.	
State:	1127B.5.3	
Federal:	303.2, 303.3, 405.4

3 - 1	Curb Ramp Priority:	
Install, r	replace or modify curb ramp	\$2,500
Notes:	The slope of one flared side is 22.6% (8.33% max with a landing less than deep). Slope of curb ramp is 10.2% (8.33% max). Cross slope of curb ram (2.0% max). Width of ramp, not including flared sides, is 44" (48" min).	
State:	1127B.5.2, 1127B.5.3, 1127B.5.4	
Federal:	405.2, 405.3, 406.1, 406.3	
Provide	detectable warning strip	\$1,000
Notes:	A detectable warning (truncated domes) is not provided.	
State:	1127B.5.7, IR11B-4	
Federal:		
i euciai.	-	
	level landing	\$250
Provide		A 48" b
	level landing Counter slope at the base of the curb ramp is more than 5.0% (5.0% max). 48" landing is not provided at the top of the ramp. Slope of one flared side	
Provide Notes: State:	level landing Counter slope at the base of the curb ramp is more than 5.0% (5.0% max). 48" landing is not provided at the top of the ramp. Slope of one flared side 9.9% (2.0% max). 1127B.5.3, 1127B.5.4	A 48" b

State:	-	
Federal:	305.2	
Relocate	e pedestrian pushbutton	\$75,000
Notes:	The pedestrian pushbutton is located over five feet from the crosswalk line extended farthest from the intersection (5' max).	
State:	CAMUTCD 4E.08	
Federal:	MUTCD 4E.08	
Poplaco	pushbutton	\$1,000
Replace		
	The operating force of the push button requires 6 lbs of force (5 lbs max).	
Notes: State:	The operating force of the push button requires 6 lbs of force (5 lbs max).

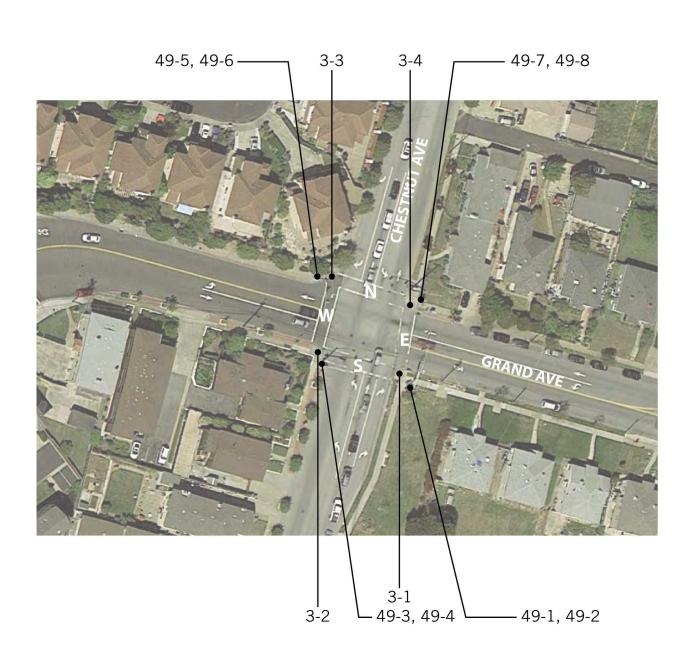
East Crosswalk 49 - 2 Pushbutton Crossing Grand Priority: Install sign on the pushbutton \$250 Notes: A sign adjacent or integrated with the pushbutton indicating purpose and use, and which crosswalk signal is actuated is not provided. CAMUTCD 4E.08 State: Federal: MUTCD 4E.08 Provide both vibrotactile and audible indicators \$1,000 Notes: The pedestrian signal does not provide vibrotactile walk indications (accessible pedestrian signals shall have both audible and vibrotactile walk indications). CAMUTCD 4E.11 State: Federal: MUTCD 4E.11 Provide color coding indicator above pedestrian pushbutton \$150 A color coding indicator is not located above the pedestrian pushbutton (textured Notes: horizontal yellow band 2" wide encircling the pole and a 1" wide dark border band above and below this yellow band). CBC 1117B.5.9 State: Federal: -Provide speech message "wait" \$1.000 The pilot light used at the accessible pedestrian signal location is not accompanied Notes: by a speech message "wait" with each actuation. CAMUTCD 4E.08 State: Federal: MUTCD 4E.08 \$1,000 Regrade surface Notes: The clear floor or ground space in front of the pushbutton has a slope of 4.4% (2.0% max). State: Federal: 305.2 Relocate pedestrian pushbutton \$75.000 The two pedestrian signal devices on the same corner are on the same pole (10' Notes:

min apart). The pedestrian pushbutton is located 11' from the edge of the curb,

North Crosswalk Curb Ramp Priority: 3 - 3 Install, replace or modify curb ramp \$2,500 The slope of flared sides are 26.0% and 23.6% (10% max). Cross slope of curb Notes: ramp is 3.4% (2.0% max). Width of ramp, not including flared sides, is 32" (48" min). State: 1127B.5.2, 1127B.5.3, 1127B.5.4 Federal: 405.2, 405.3, 406.1, 406.3 \$1,000 Provide detectable warning strip A detectable warning (truncated domes) is not provided. Notes: State: 1127B.5.7, IR11B-4 Federal: -Provide level landing \$250 Counter slope at the base of the curb ramp is 9.3% (5.0% max). The top landing is Notes: 44" by 48" (48" by 48" min). Slope of the top landing is 6.0% (2.0% max). State: 1127B.5.3, 1127B.5.4 Federal: 406.2 Provide surface texturing \$1,000 Notes: Grooved border is 8" wide (12" min width with grooves 3/4" on center). Surface finish does not contrast with surrounding sidewalks. State: 1127B.5.5, 1127B.5.6 Federal: -

State:	CAMUTCD 4E.08		
Federal:	MUTCD 4E.08		
Provide	vibrotactile arrow on pushbutton		\$1,000
Notes:	The tactile arrow on the accessible pedestrian signal dewalk interval.	oes not vibrate duri	ng the
State:	CAMUTCD 4E.11		
Federal:	MUTCD 4E.11		
Relocate	e pedestrian pushbutton		\$75,000
Notes:	The two pedestrian signal devices on the same corner min apart). The pedestrian pushbutton is located 10-1/2 shoulder or pavement (1-1/2' min to 6' max).		,
State:	CAMUTCD 4E.08		
Federal:	MUTCD 4E.08		
Replace	pushbutton		\$1,000
Notes:	The operating force of the push button requires more the	nan 5 lbs of force (5	lbs max).
State:	-		
Federal:	309.4

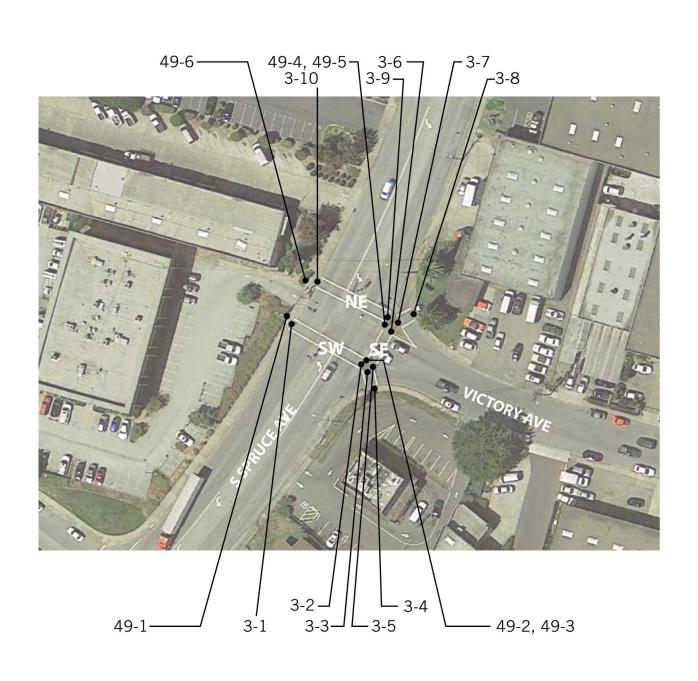
035: Spruce & Victory

Northeast Crosswalk 3 - 9 Curb Ramp Priority: Provide or relocate crossing or curb markings \$500 A curb ramp is not provided at the corner of a street intersection where a pedestrian Notes: sidewalk crosses the curb. 1127B.5
